# Blue® Series and Legacy Series Make up Acceptance

## COMPUTER GRAPH BLUE® SERIES AND LEGACY SERIES

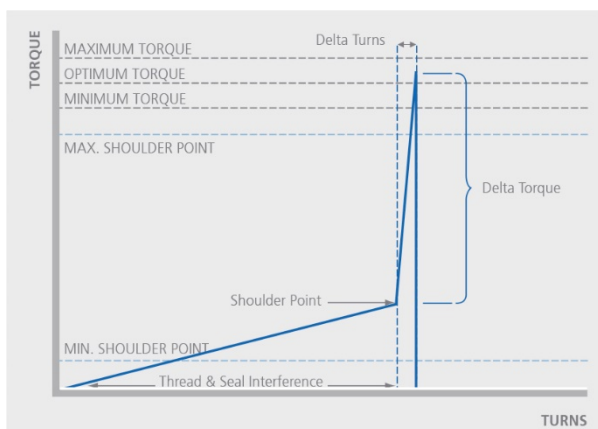
#### TYPICAL GRAPH PROFILE

5. The four basic component parts of a graph should exhibit the following characteristics to be acceptable:

- Smooth, continuous thread and seal interference build exhibiting no unusual discontinuities.
- A distinct, identifiable shoulder point within set shoulder parameters.
- An exponential delta torque build after shoulder point exhibiting no discontinuities.
- Delta turns within acceptable parameters.

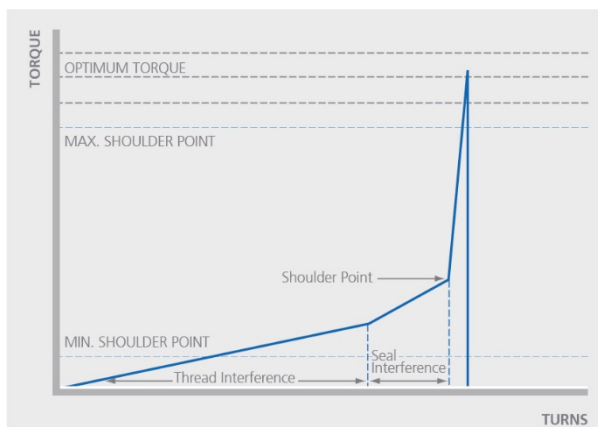
8. Occasionally some connections can exhibit a change in angle during seal engagement, this is perfectly acceptable. This profile may be evident on every make up of a particular string or may occur sporadically throughout the run.

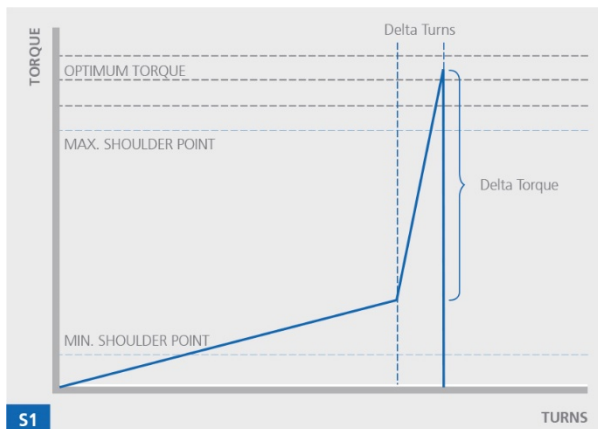
### S1 - TYPICAL GRAPH

The acceptance criteria for Blue® Series or Legacy Series threaded and coupled connections are as follows:

- A final torque above minimum and below maximum.
- Shoulder point within limits, when applicable.
- The maximum delta turn can be no more than:
  - 0.12 turns for sizes 5 1/2" and below
  - 0.10 turns for sizes above 5 1/2"

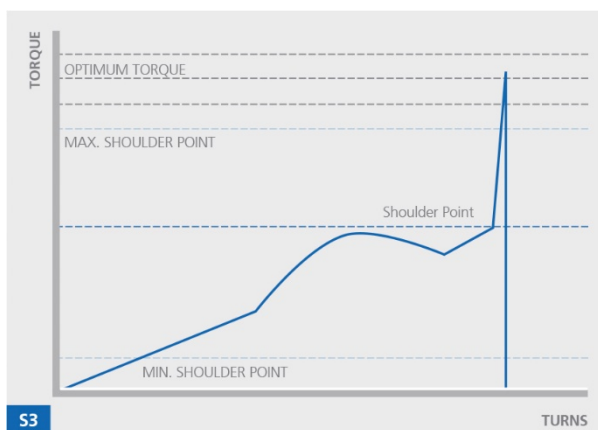
### S3 - HUMP BELOW SHOULDER POINT

Thread and seal build profile with smooth hump effect not exceeding shoulder point.

- Excessive running compound
- High friction factor running compound
- Slight misalignment
- Pipe sway
- Rig movement
- Pipe bend
- Contact on pipe by other equipment

- If no obvious reason is evident break out the first make up and inspect both connections for damage, if no damage found continue to accept similar graph profiles.

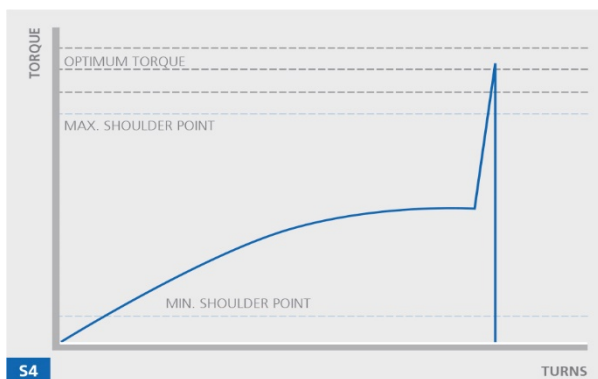
## S4 - CURVED TORQUE BUILD SECTION

- Excess thread compound
- High friction factor thread compound
- Low temperature thread compound
- Pipe sway
- Rig movement
- Pipe bend
- Contact on pipe body by other equipment

- If thread and seal interference build section displays a smooth profile, the graph is acceptable.
- If compound is thought to be the cause ensure it is fully stirred and warm if possible.
- Eradicate any contact by other equipment during make up.

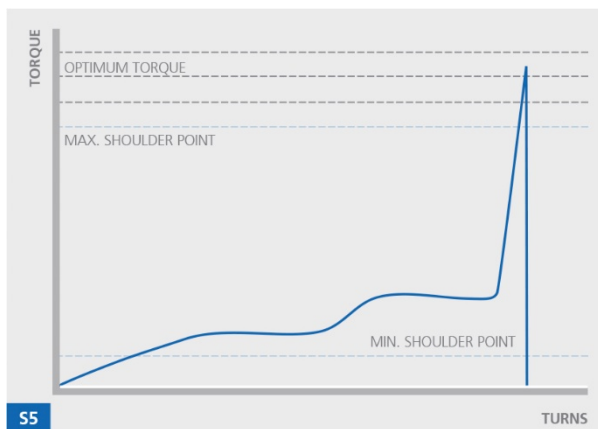
## S5 - MINOR OSCILATIONS PRIOR TO SHOULDER

- Pipe sway
- Pipe bend
- Rig movement
- Contact on pipe body by other equipment
- Excessive spin in speed

- Minor, smooth oscillations during thread and seal interference build profile can be accepted.
- Reduce rotation speed if pipe sway, rig movement or pipe bend is the reason.
- Stabilize pipe during make up.
- Eradicate any contact by other equipment.

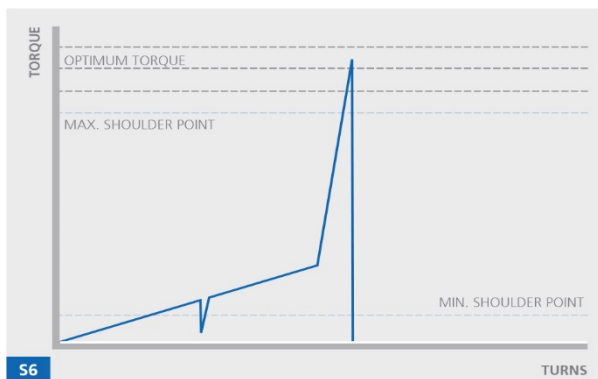
## S6 - TONG SLIP DURING THREAD AND SEAL BUILD

- Clogged tong dies
- Worn tong dies
- Incorrect dies or tong jaws
- Tong not level
- Snub line movement
- Wet or oil covered pipe OD.

- Accept if the tong slip is momentary and the torque build returns to previous build slope.
- Clean or replace tong dies
- Ensure tong and back up are level and dies contact pipe OD evenly.

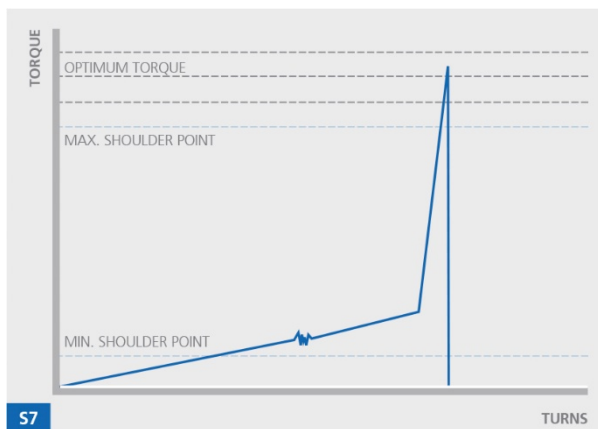
## S7 - MINOR THREAD INTERFERENCE

- Electrical interference
- Momentary contact on pipe, elevators, etc.

- Minor interference during thread interference build can be accepted.
- Identify cause and eradicate if possible

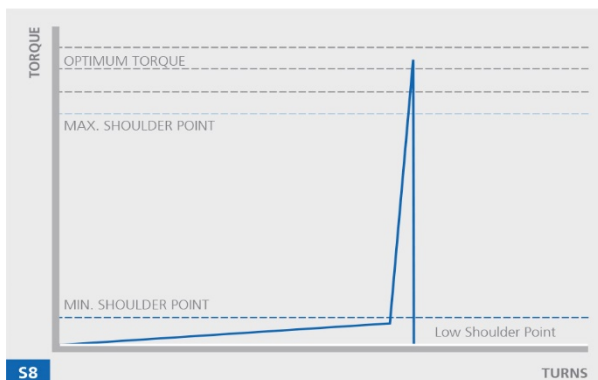
## S8 - LOW SHOULDER

- Incorrect torque applied
- Incorrect thread compound friction factor
- Contaminated thread compound
- Substance contamination of connections
- Storage compound not cleaned off prior to application of thread compound
- Other friction reducer
- Incorrect load cell / data reading
- Low thread interference

- The make up graph is unacceptable, except for TXP®, SLX®, MACII™, PH6™, PH4™ and CS® (which only require a visible shoulder point).
- Break out, clean and inspect both connections for damage.
- Ensure connections are cleaned using methods recommended in cleaning section of this document.
- Ensure connections are dry whenever possible.

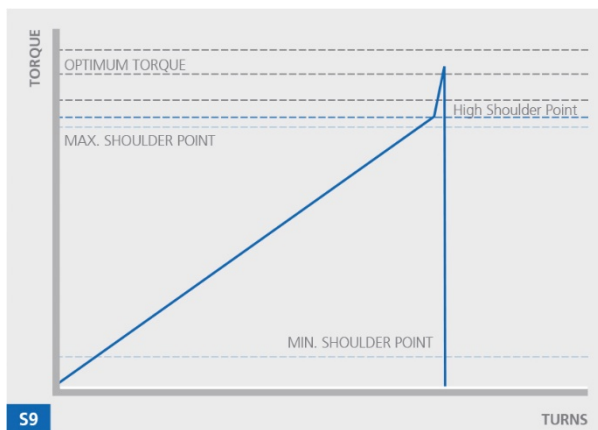
## S9 - HIGH SHOULDER

- Incorrect torque
- Incorrect running compound
- Contaminated or lack of running compound
- High thread interference
- Incorrect friction factor
- Load cell problem
- Misalignment

- The make up graph is unacceptable, except for TXP® BTC, TenarisHydril SLX®, TenarisHydril MACII™, TenarisHydril PH6™, TenarisHydril PH4™ and TenarisHydril CS® (which only require a visible shoulder point)
- Break out, clean and inspect both connections for damage.
- If no damage found re-apply thread compound increasing the amount applied while maintaining the recommended distribution, then re-make up connection.

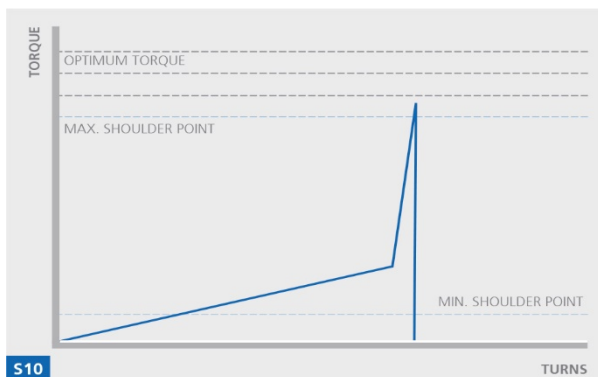
## S10 - LOW FINAL TORQUE

- Incorrect torque input
- Incorrect dump valve function
- Load cell error
- Operator error

- The make up graph is unacceptable.
- Break out clean and inspect both connections for damage.
- If no damage found re-apply thread compound then re-make up connection.

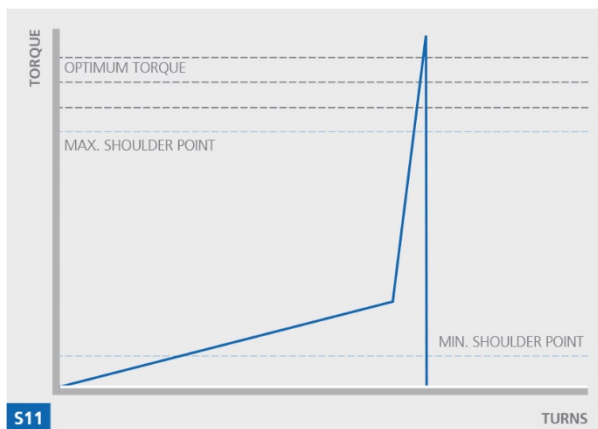
## S11 - HIGH FINAL TORQUE

- Incorrect torque
- Incorrect dump valve function
- Load cell error
- Operator error
- Excessive RPM at final torque

- If the final torque is below operating torque and all other parameters are within limits, a smooth make up graph can be accepted.
- Take actions to avoid exceeding torque in subsequent make ups.

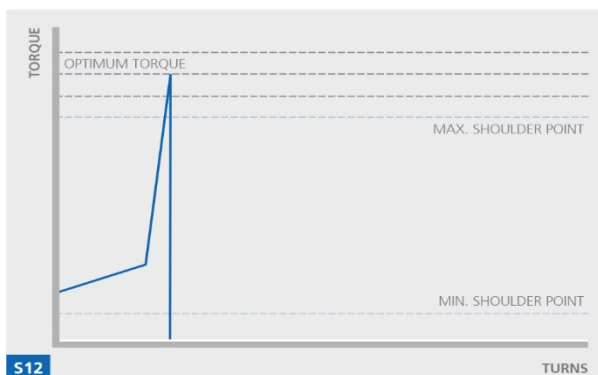
## S12 –SHORT / INCOMPLETE GRAPH

- Reference torque set too high
- Late gear change
- High initial interference
- Cross-threading
- Computer operator started the graph late

- The make up graph is unacceptable.
- Break out, clean and inspect both connections for damage.
- If no damage found re-apply thread compound then re-make up connection.
- Lower reference torque.
- Stabilize pipe during stabbing and make up.

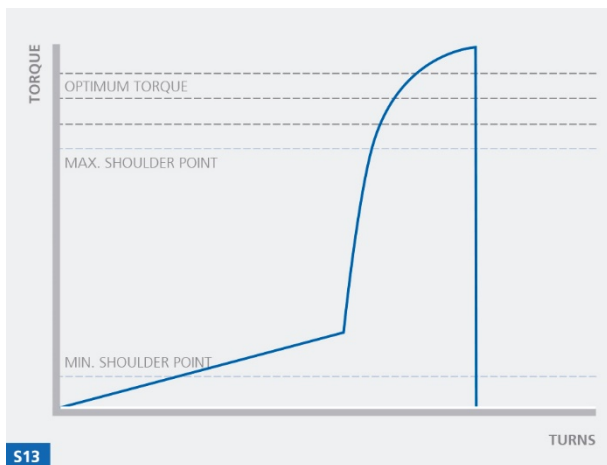
### S13 - OVERTORQUE WITH YIELD

- Incorrect torque
- Incorrect thread compound
- Contaminated thread compound
- Storage compound not cleaned off correctly
- Incorrect friction factor
- Disparity of connection grade / weight
- Load cell error
- Equipment malfunction
- Incorrect tong arm length
- Operator error

- The make up graph is unacceptable.
- If delta turns and/or torque applied exceed the acceptable limit reject both pin and box connections.

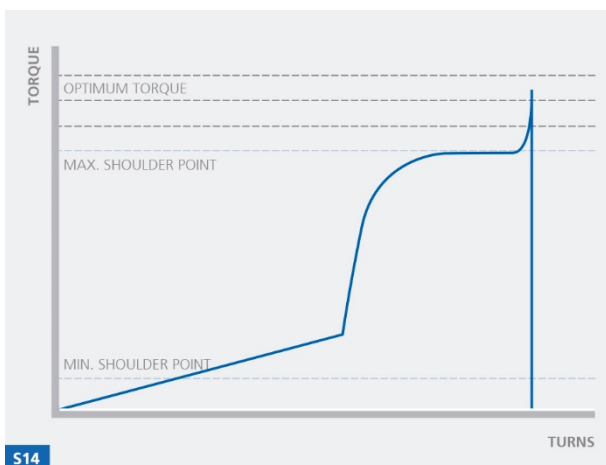
## S14 – YIELDED CONNECTION

- Incorrect torque
- Incorrect thread compound
- Contaminated thread compound
- Storage compound not cleaned off correctly
- Incorrect friction factor
- Disparity of connection grade / weight
- Load cell error
- Equipment malfunction
- Incorrect tong arm length
- Operator error

- The make up graph is unacceptable.
- Reject both pin and box connections.

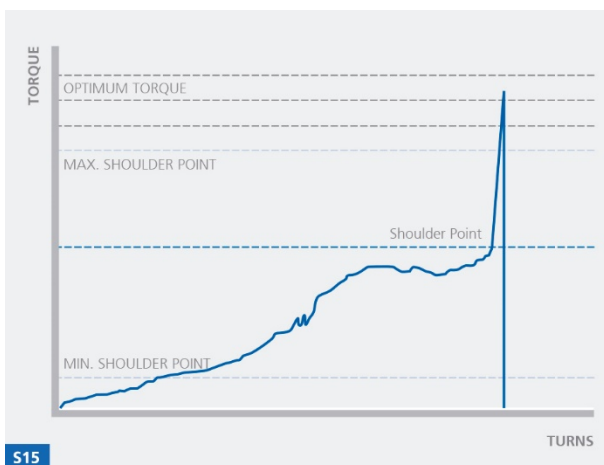
## S15 - ERRATIC THREAD INTERFERENCE

- Incorrect thread compound
- Contaminated thread compound
- Misalignment
- High rotation speed
- Pipe movement during spin in
- Damaged threads
- Debris on connections

- The make up graph is unacceptable.
- Break out, clean and inspect both connections for damage.
- If no damage found re-apply thread compound then re-make up connection.

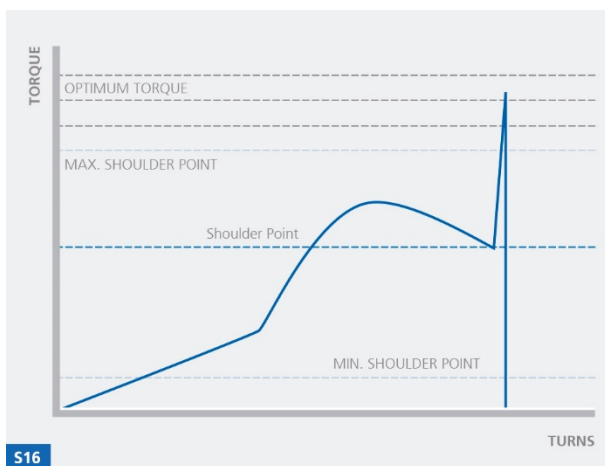
## S16 - HUMP EXCEEDING SHOULDER POINT

- Excessive thread compound application
- Contaminated thread compound
- Debris on connections
- High friction factor thread compound
- Pipe movement during spin in
- External contact on pipe from other equipment
- Misalignment

- **Connections without metal seal:** The make up graph is acceptable.
- **Connections with metal seal:** Break out connections, clean and inspect both connections for damage. If no damage found re-apply thread compound, reducing quantity then re-make up connection.
- Eradicate any other external influence causing this effect

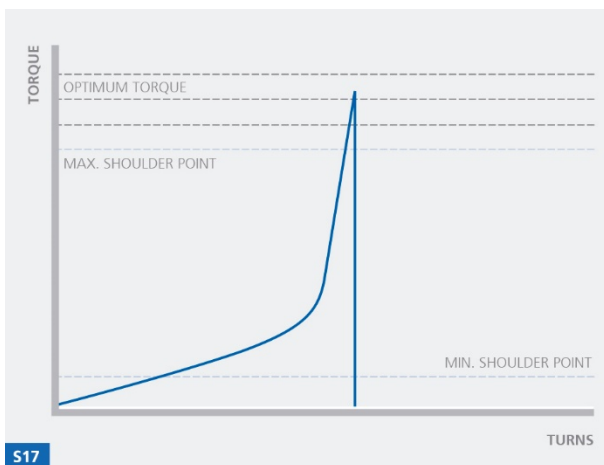
## S17 - NON-DEFINED SHOULDER POINT

- Incorrect torque
- Misalignment
- Pipe movement during spin in
- Debris on threads
- High friction factor thread compound
- Excessive thread compound application
- Slow final rotation speed
- False shoulder encountered

- The make up graph is unacceptable.
- Break out, clean and inspect both connections for damage.
- If no damage found re-apply thread compound then re-make up connection.
- Increase RPM during final make up if possible

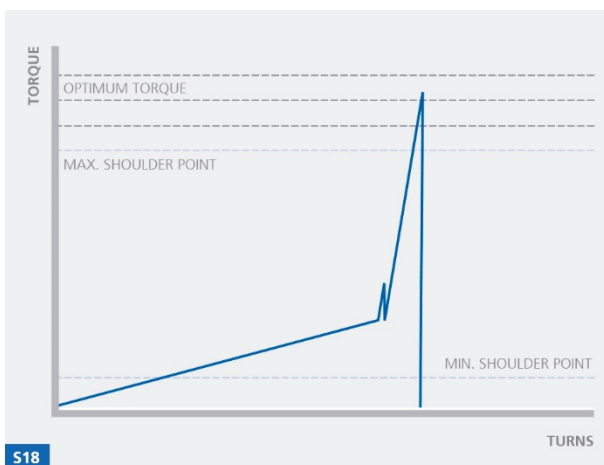
## S18 – SPIKE PRIOR TO SHOULDER POINT

- Galling of threads or seal
- Contaminated thread compound
- Debris on threads / seals
- Sudden pipe movement prior to shoulder
- Contact on pipe from external equipment
- Misalignment

- The make up graph is unacceptable.
- Break out, clean and inspect both connections for damage.
- If no damage found re-apply thread compound then re-make up connection.
- If the anomaly persists during the run, check for external equipment contact on pipe.
- If the issue cannot be eradicated and no detrimental effect found on connection, accept further similar graphs.

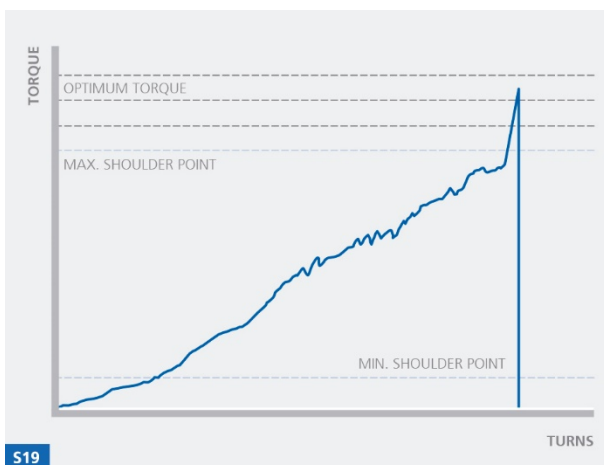
## S19 – HIGH AND ERRATIC THREAD INTERFERENCE

- Galled threads
- Contaminated thread compound
- Incorrect thread compound
- Debris on threads
- Damaged threads
- Misalignment
- Crossed threads
- High spin in speed
- Pipe movement during spin in
- Electrical interference

- The make up graph is unacceptable.
- Break out, clean and inspect both connections for damage.
- If no damage found re-apply thread compound then re-make up connection.

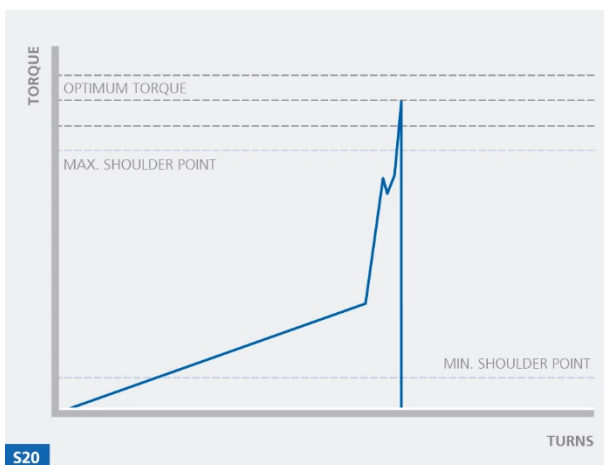
## S20 – DISCONTINUOUS DELTA TORQUE BUILD

- Galled threads
- Damaged threads
- Misalignment
- Crossed threads
- Tong slip
- Rotary turning during make up

- The make up graph is unacceptable.
- Break out, clean and inspect both connections for damage.
- If no damage found re-apply thread compound then re-make up connection.
- If tong slip is the cause clean or replace dies.
- Lock the rotary table.

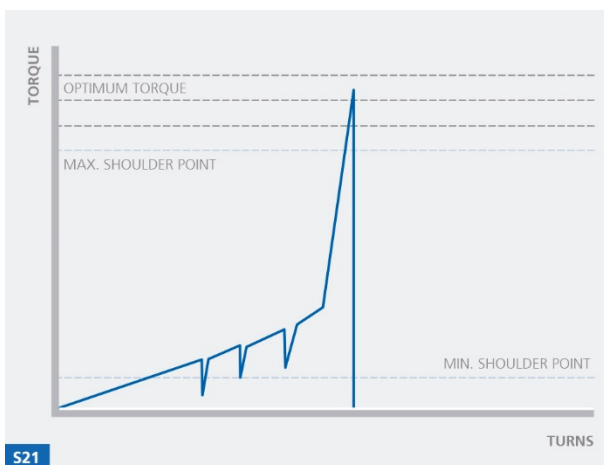
## S21 – MULTIPLE TONG SLIPS

- Clogged tong dies
- Worn tong dies
- Incorrect dies or tong jaws
- Tong not level
- Snub line movement
- Wet or oil covered pipe OD

- The make up graph is unacceptable.
- Break out clean and inspect both connections and pipe body for damage.
- If no damage found re-apply thread compound, then re-make up connection
- Clean or replace tong dies.
- Ensure tong and back up is level and dies contact pipe OD evenly.

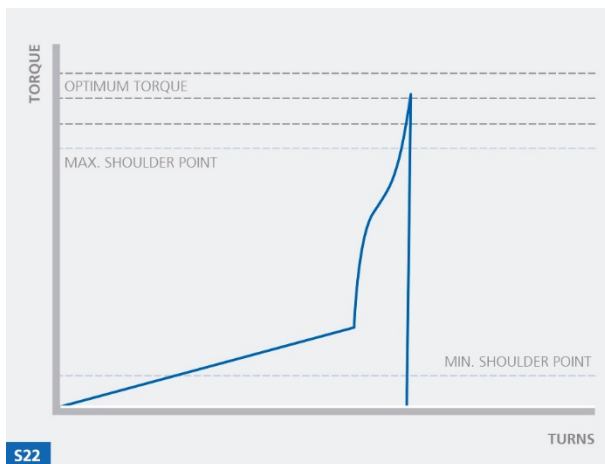
## S22 – NON-LINEAR DELTA TORQUE BUILD

- Coupling turn
- Minor yield
- External contact on pipe from other equipment
- Compression load cell restriction

- The make up graph is unacceptable.
- Break out, clean and inspect both connections for damage.
- If no damage found re-apply thread compound then re-make up connection.
- Eradicate any contact from external equipment.
- Check for obstructions within the load cell bracket.

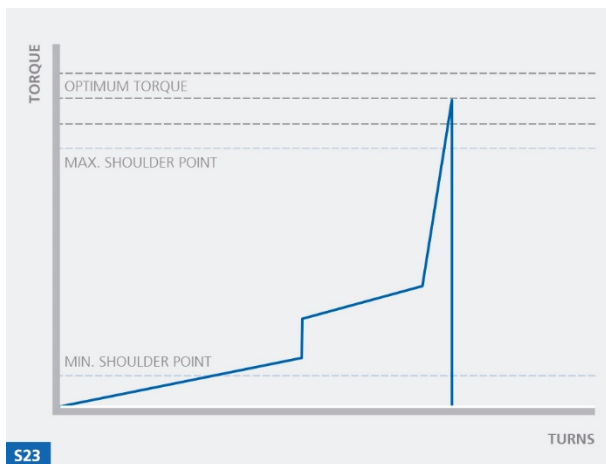
## S23 –TORQUE STEP

- Turns counter malfunction

- The make up graph is unacceptable.
- Break out, clean and inspect both connections for damage.
- If no damage found re-apply thread compound then re-make up connection.

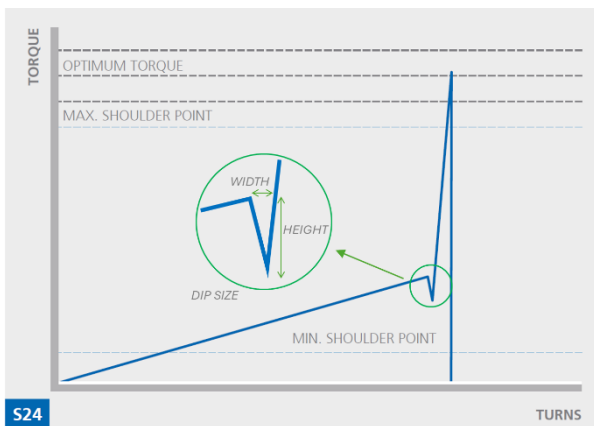
## S24 –DIP PRIOR TO SHOULDER

- Minor back up tong movement just prior to shoulder
- Back up tong not completely level
- Dope squeeze

- **Connections without metal seal:** The make up graph is acceptable
- **Connections with metal seal:** Analyze the size of the dip and proceed as indicated below.
  - If the dip width is 0.015 turns or below and dip height is 5% of optimum torque maximum, accept the make up graph.
  - If the dip width and/or height is larger than indicated above, the make up graph is unacceptable. Break out, clean and inspect both connections for damage. If no damage found re-make connections.
  - Adjust back up tong to prevent re-occurrence.
  - If the anomaly persists during the run and the issue cannot be eradicated, open and check the first connection, and if no damage is found accept further similar graphs.
