# 09.Blue® Series and Legacy Series Make up Acceptance

## COMPUTER GRAPH BLUE® SERIES AND LEGACY SERIES

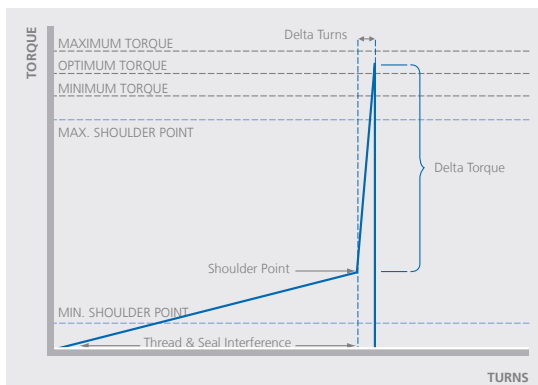
#### TYPICAL GRAPH PROFILE

5. The four basic component parts of a graph should exhibit the following characteristics:

- Smooth, continuous thread and seal interference build exhibiting no unusual discontinuities.
- A distinct, identifiable shoulder point within set shoulder parameters.
- An exponential delta torque build after shoulder point exhibiting no discontinuities.
- Delta turns.

3. A computer graph for a shouldered connection can essentially be broken down into four component parts:

- Thread and seal interference build slope.
- Distinct, identifiable shoulder point within set shoulder parameters.
- Linear delta torque build to within set torque parameters after shoulder.
- Delta turns.

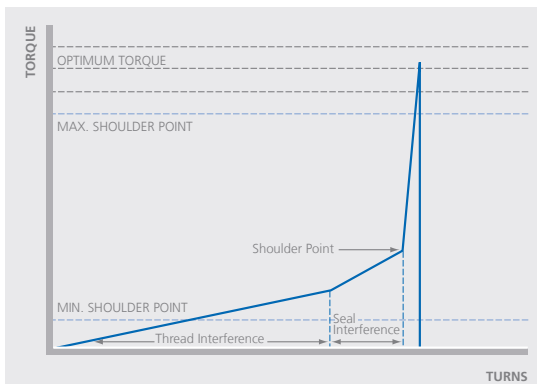
7. Occasionally some connections can exhibit a change in angle during seal engagement this is perfectly acceptable. This profile may be evident on every make up of a particular string or may occur sporadically throughout the run.

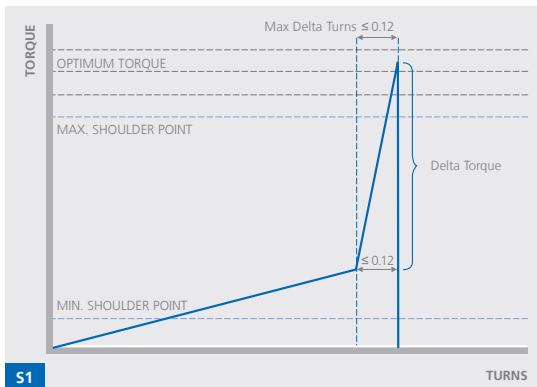
### ACCEPTABLE

For Blue® Series and Legacy Series threaded and coupled connections there is a maximum allowable delta turn criteria which should be applied.

The criteria for maximum allowable delta turn of Blue® Series or Legacy Series threaded and coupled connections, in sizes 5 1/2" and below is as follows:

- A final torque above minimum and below maximum must be attained.
- The maximum delta turn can be no more than 0.12 of a turn.

- Loss of linearity is allowed within the acceptable maximum delta turn.
- For any delta above 0.12 of a turn reject both connections.

Above 5 1/2" both for Blue® Series and Legacy Series threaded and coupled connections the maximum delta criteria is 0.1 with or without loss of linearity.

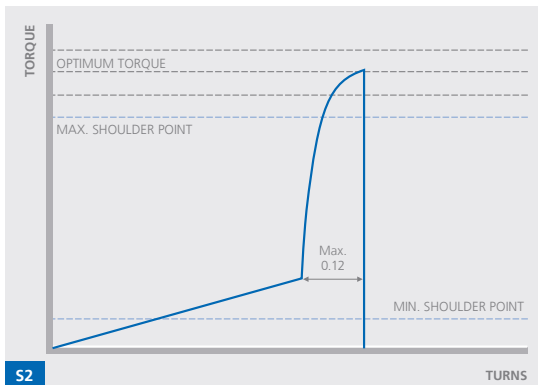
### ACCEPTABLE

For pipe sizes 5 1/2" and below, if a graph with a larger than normal delta turn is displayed, with or without loss of linearity, the process to follow is:

- A final torque above minimum and below maximum must be attained.
- Expand the graph and ensure the shoulder point is accurately indicated, adjust if necessary.
- If the delta turn is  $> 0.12$  reject both connections.
- If the delta turn is  $\leq 0.12$  accept the make up.
- For pipe sizes above 5 1/2" the maximum acceptable delta turn is 0.1.

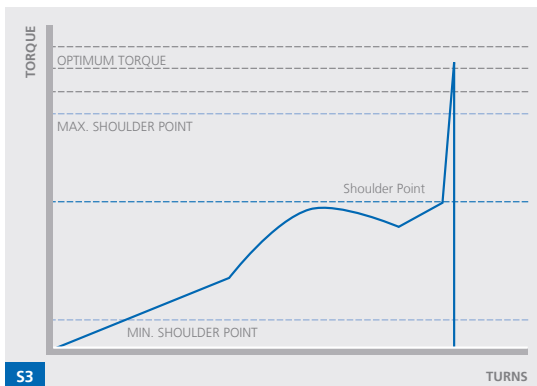
### ACCEPTABLE

Thread and seal build profile with smooth hump effect not exceeding shoulder point.

- Excessive running compound
- High friction factor running compound
- Slight misalignment
- Pipe sway
- Rig movement
- Pipe bend
- Contact on pipe by other equipment

If no obvious reason is evident break out the first make up and inspect both connections for damage, if no damage found continue to accept similar graph profiles.

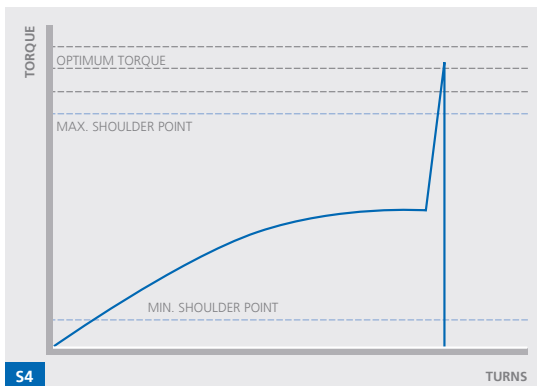
### ACCEPTABLE

Curved thread and seal interference build with smooth profile.

- Excess thread compound
- High friction factor thread compound
- Low temperature thread compound
- Pipe sway
- Rig movement
- Pipe bend
- Contact on pipe by other equipment

If compound is thought to be the cause ensure it is fully stirred and warm if possible. Eradicate any contact by other equipment during make up.

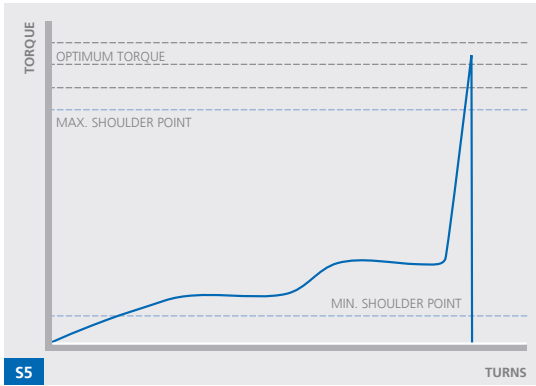
### ACCEPTABLE

Minor, smooth oscillations during thread and seal interference build profile.

- Pipe sway
- Pipe bend
- Rig movement
- Contact on pipe by other equipment
- Excessive spin in speed

Reduce rotation speed if pipe sway, rig movement or pipe bend is the reason.

Stabilize pipe during make up. Eradicate any contact by other equipment.

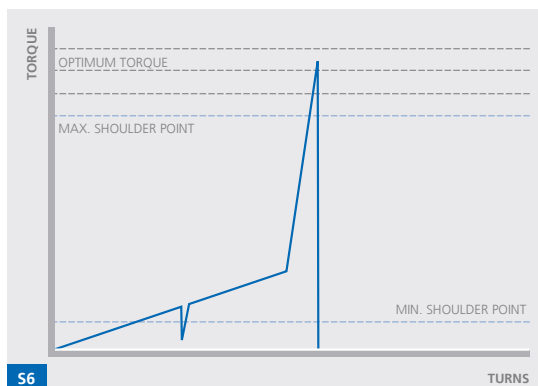
### ACCEPTABLE

Single tong slip during thread and seal build.

- Clogged tong dies
- Worn tong dies
- Incorrect dies or tong jaws
- Tong not level
- Snub line movement
- Wet or oil covered pipe OD

- Clean or replace tong dies.
- Ensure tong and back up is level and dies contact pipe OD evenly.

Accept if the tong slip is momentary and the torque build returns to previous build slope.

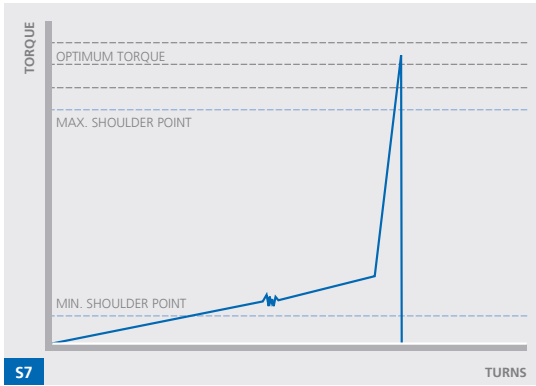
### ACCEPTABLE

Minor interference during thread interference build.

- Electrical interference
- Momentary contact on pipe, elevators, etc.

Identify cause and eradicate if possible.

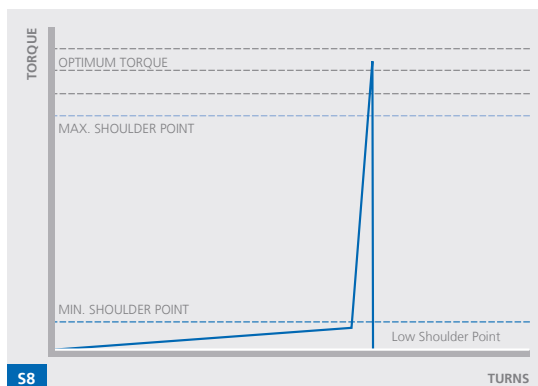
### UNACCEPTABLE

Low shoulder point.

- Incorrect torque applied
- Incorrect thread compound friction factor
- Contaminated thread compound
- Substance contamination of connections
- Storage compound not cleaned off prior to application of thread compound
- Other friction reducer
- Incorrect load cell / data reading
- Low thread interference

- Break out, clean and inspect both connections for damage.
- Ensure connections are cleaned using methods recommended in cleaning section of this document.
- Ensure connections are dry if possible.
- If no damage found decrease amount of thread compound applied, respecting recommended distribution then re-make up connection.

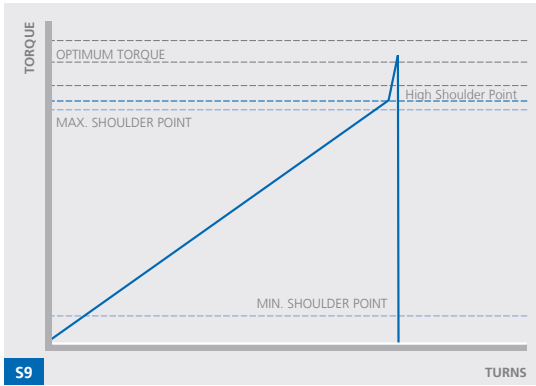
### UNACCEPTABLE

High shoulder point.

- Incorrect torque
- Incorrect running compound
- Contaminated running compound
- High thread interference
- Incorrect friction factor
- Load cell problem
- Misalignment

- Break out, clean and inspect both connections for damage.
- If no damage found re-apply thread compound increasing the amount applied respecting the recommended distribution then re-make up connection.

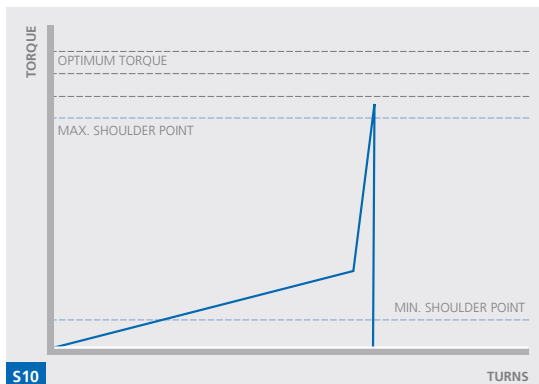
### UNACCEPTABLE

Low final torque.

- Incorrect torque input
- Incorrect dump valve function
- Load cell error
- Operator error

- Break out clean and inspect both connections for damage.
- If no damage found re-apply thread compound then re-make up connection.

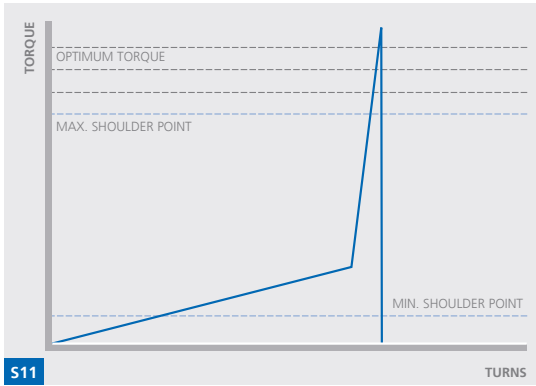
### UNACCEPTABLE

High final torque.

- Incorrect torque
- Incorrect dump valve function
- Load cell error
- Operator error
- High momentum

- Break out clean and inspect both connections for damage.
- If no damage found re-apply thread compound then re-make up connection.

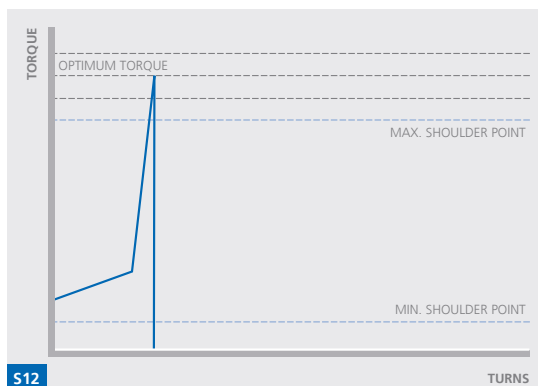
### UNACCEPTABLE

Short / incomplete graph.

- Reference torque set too high
- Late gear change
- High initial interference

- Break out clean and inspect both connections for damage.
- If no damage found re-apply thread compound then re-make up connection.
- Lower reference torque.
- Stabilize pipe during stabbing and make up.

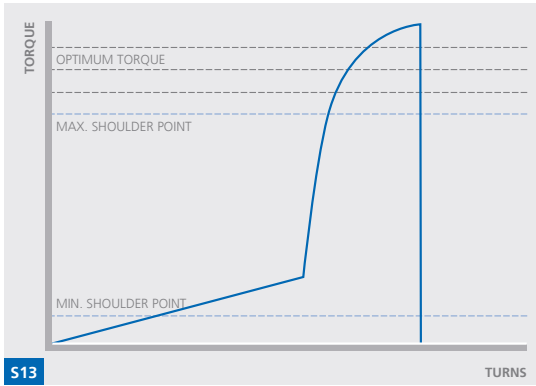
### UNACCEPTABLE

Over torque with yield.

- Incorrect torque
- Incorrect thread compound
- Contaminated thread compound
- Storage compound not cleaned off correctly
- Incorrect friction factor
- Disparity of connection grade / weight
- Load cell error
- Equipment malfunction
- Incorrect tong arm length
- Operator error

Reject both pin and box connections.

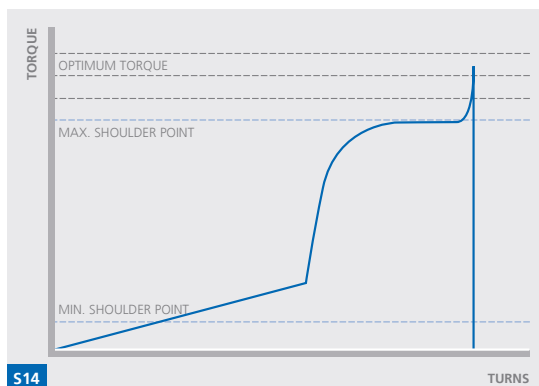
### UNACCEPTABLE

Yielded connection.

- Incorrect torque
- Incorrect thread compound
- Contaminated thread compound
- Storage compound not cleaned off correctly
- Incorrect friction factor
- Disparity of connection grade / weight
- Load cell error
- Equipment malfunction
- Incorrect tong arm length
- Operator error

Reject both pin and box connections.

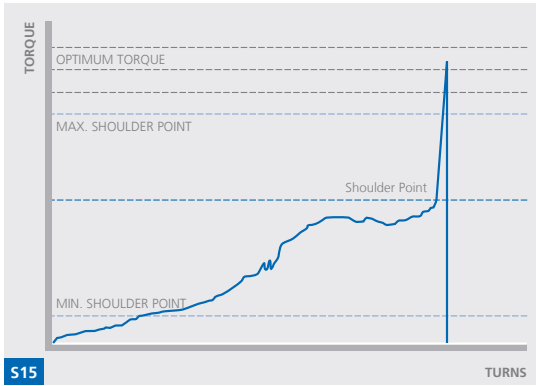
### UNACCEPTABLE

Erratic thread and seal build,  
indications of galling.

- Incorrect thread compound
- Contaminated thread compound
- Misalignment
- High rotation speed
- Pipe movement during spin in
- Damaged threads
- Debris on connections

- Break out, clean and inspect both connections for damage.
- If no damage found re-apply thread compound then re-make up connection.

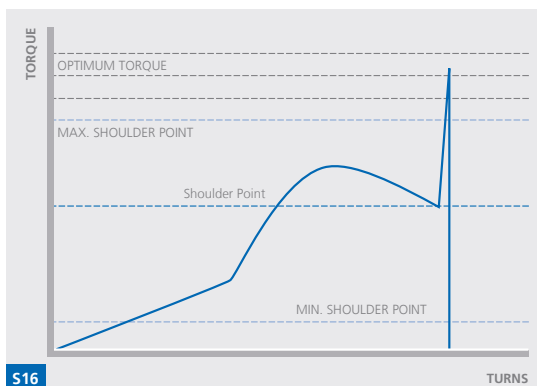
### UNACCEPTABLE

Hump effect exceeding final shoulder.

- Excessive thread compound application
- Contaminated thread compound
- Debris on connections
- High friction factor thread compound
- Pipe movement during spin in
- External contact on pipe from other equipment
- Misalignment

- Break out connections exhibiting this profile, clean and inspect both connections for damage.
- If no damage found re-apply thread compound, reducing quantity then re-make up connection.
- Eradicate any other external influence causing this effect.

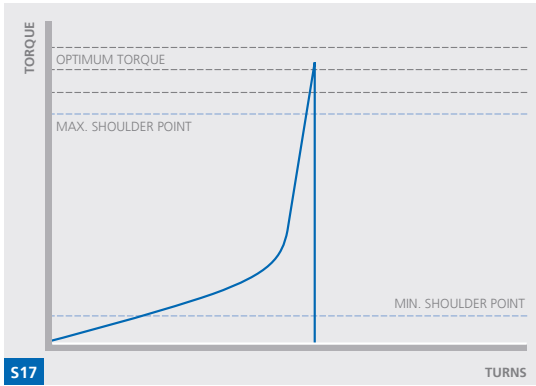
### UNACCEPTABLE

Non defined shoulder point.

- Incorrect torque
- Misalignment
- Pipe movement during spin in
- Debris on threads
- High friction factor thread compound
- Excessive thread compound application
- Slow final rotation speed
- False shoulder encountered

- Break out, clean and inspect both connections for damage.
- If no damage found re-apply thread compound then re-make up connection.

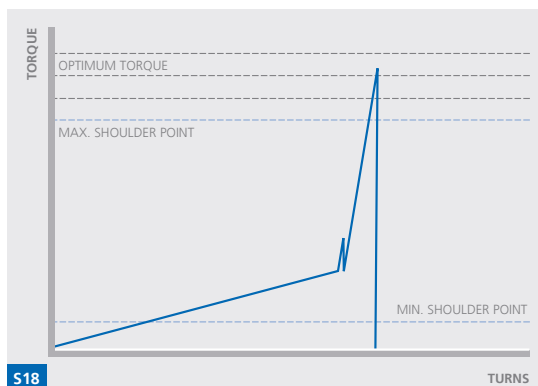
### UNACCEPTABLE

Sharp spike or interference prior to shoulder point.

- Galling of threads or seal
- Contaminated thread compound
- Debris on threads / seals
- Sudden pipe movement prior to shoulder
- Contact on pipe from external equipment
- Misalignment

- Break out, clean and inspect both connections for damage.
- If no damage found re-apply thread compound then re-make up connection.
- Eradicate any external equipment contact on pipe.

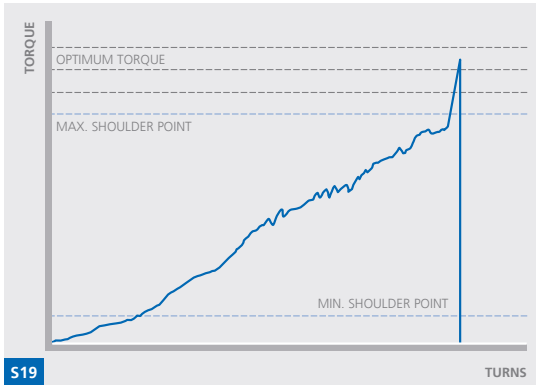
### UNACCEPTABLE

High and erratic thread interference.

- Galled threads
- Contaminated thread compound
- Incorrect thread compound
- Debris on threads
- Damaged threads
- Misalignment
- Crossed threads
- High spin in speed
- Pipe movement during spin in

- Break out, clean and inspect both connections for damage.
- If no damage found re-apply thread compound then re-make up connection.

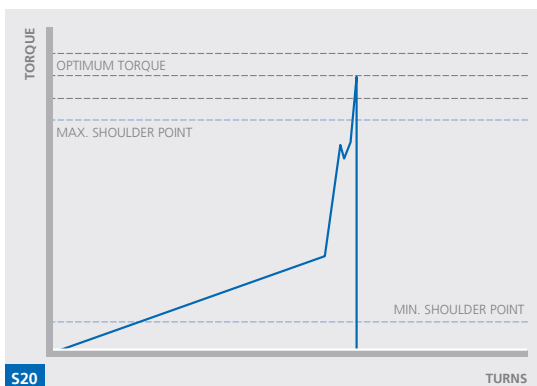
### UNACCEPTABLE

Discontinuous delta torque build.

- Galled threads
- Damaged threads
- Misalignment
- Crossed threads
- Tong slip

- Break out, clean and inspect both connections for damage.
- If no damage found re-apply thread compound then re-make up connection.
- If tong slip is the cause clean or replace dies.

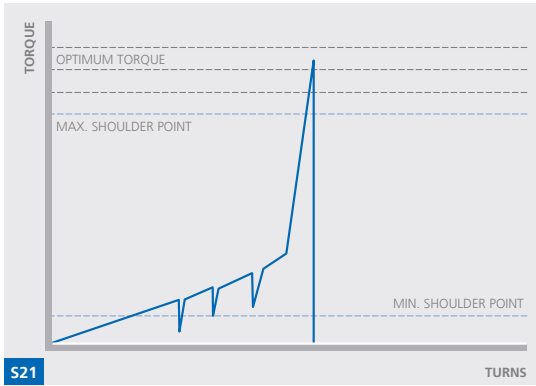
### UNACCEPTABLE

Multiple tong slip.

- Clogged tong dies
- Worn tong dies
- Incorrect dies or tong jaws
- Tong not level
- Snub line movement
- Wet or oil covered pipe OD

- Break out clean and inspect both connections for damage.
- If no damage found re-apply thread compound then re-make up connection.

- Clean or replace tong dies.
- Ensure tong and back up is level and dies contact pipe OD evenly.

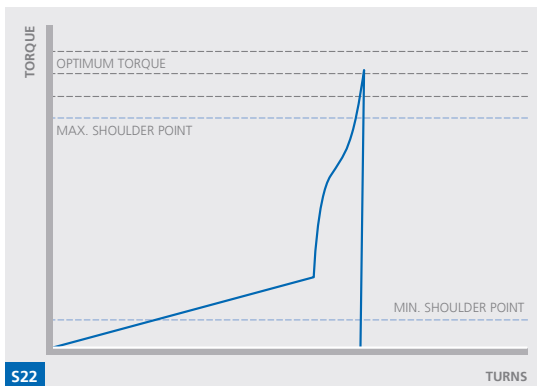
### UNACCEPTABLE

Discontinuous delta torque build.

- Coupling turn
- Minor yield
- External contact on pipe from other equipment

- Break out, clean and inspect both connections for damage.
- If no damage found re-apply thread compound then re-make up connection.
- Eradicate any contact from external equipment.

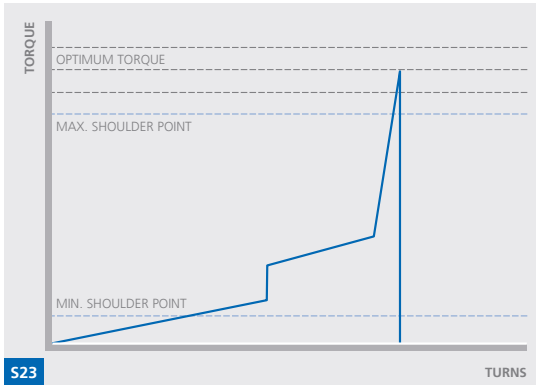
### UNACCEPTABLE

Turns counter malfunction.

- Break out, clean and inspect both connections for damage.
- If no damage found re-apply thread compound then re-make up connection.
- Remedy turns counter malfunction.
