09.Blue® Series and Legacy Series Make up Acceptance

COMPUTER GRAPH BLUE® SERIES AND LEGACY SERIES

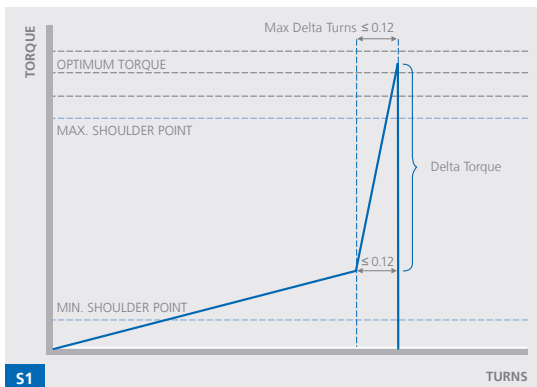
ACCEPTABLE

For Blue® Series and Legacy Series threaded and coupled connections there is a maximum allowable delta turn criteria which should be applied.

The criteria for maximum allowable delta turn of Blue® Series or Legacy Series threaded and coupled connections, including Dopeless® technology, in sizes 5 1/2" and below is as follows:

- A final torque above minimum and below maximum must be attained.
- The maximum delta turn can be no more than 0.12 of a turn.

- Loss of linearity is allowed within the acceptable maximum delta turn.
- For any delta above 0.12 of a turn reject both connections.

Above 5 1/2" both for Blue® Series and Legacy Series threaded and coupled connections the maximum delta criteria is 0.1 with or without loss of linearity.

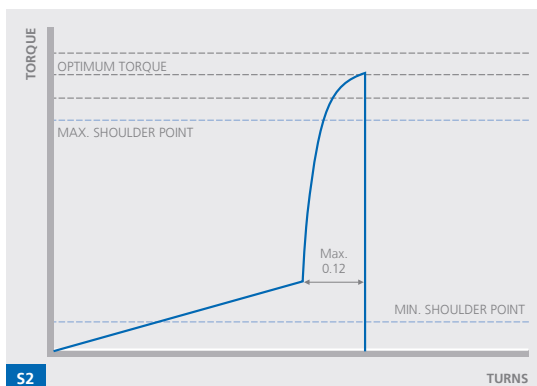
ACCEPTABLE

For pipe sizes 5 1/2" and below, if a graph with a larger than normal delta turn is displayed, with or without loss of linearity, the process to follow is:

- A final torque above minimum and below maximum must be attained.
- Expand the graph and ensure the shoulder point is accurately indicated, adjust if necessary.
- If the delta turn is > 0.12 reject both connections.
- If the delta turn is ≤ 0.12 accept the make up.
- For pipe sizes above 5 1/2" the maximum acceptable delta turn is 0.1.

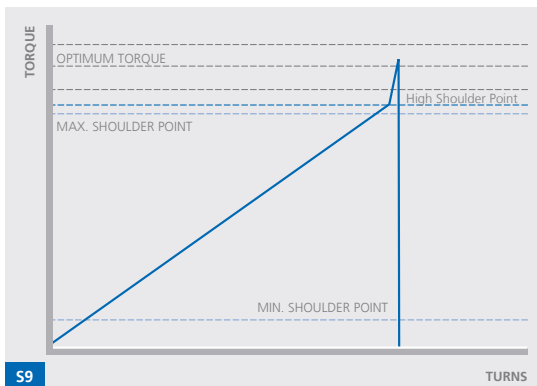
UNACCEPTABLE

High shoulder point.

- Incorrect torque
- Incorrect running compound
- Contaminated running compound
- High thread interference
- Incorrect friction factor
- Load cell problem
- Misalignment

- Break out, clean and inspect both connections for damage.
- If no damage found re-apply thread compound increasing the amount applied respecting the recommended distribution then re-make up connection.

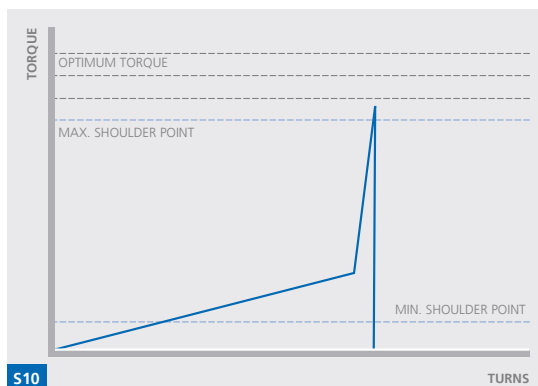
UNACCEPTABLE

Low final torque.

- Incorrect torque input
- Incorrect dump valve function
- Load cell error
- Operator error

- Break out clean and inspect both connections for damage.
- If no damage found re-apply thread compound then re-make up connection.

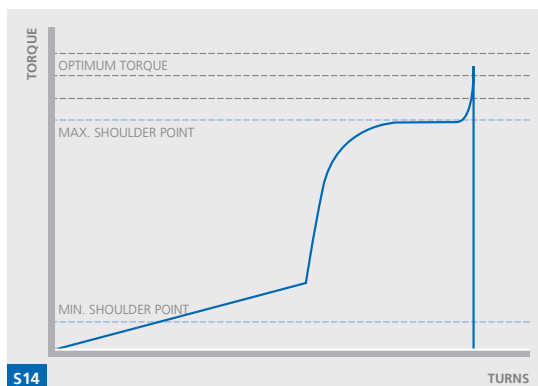
UNACCEPTABLE

Yielded connection.

- Incorrect torque
- Incorrect thread compound
- Contaminated thread compound
- Storage compound not cleaned off correctly
- Incorrect friction factor
- Disparity of connection grade / weight
- Load cell error
- Equipment malfunction
- Incorrect tong arm length
- Operator error

Reject both pin and box connections.

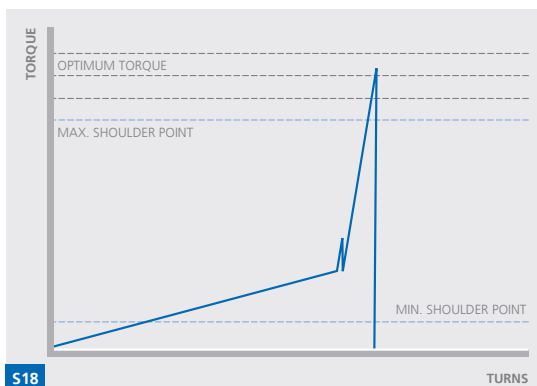
UNACCEPTABLE

Sharp spike or interference prior to shoulder point.

- Galling of threads or seal
- Contaminated thread compound
- Debris on threads / seals
- Sudden pipe movement prior to shoulder
- Contact on pipe from external equipment
- Misalignment

- Break out, clean and inspect both connections for damage.
- If no damage found re-apply thread compound then re-make up connection.
- Eradicate any external equipment contact on pipe.

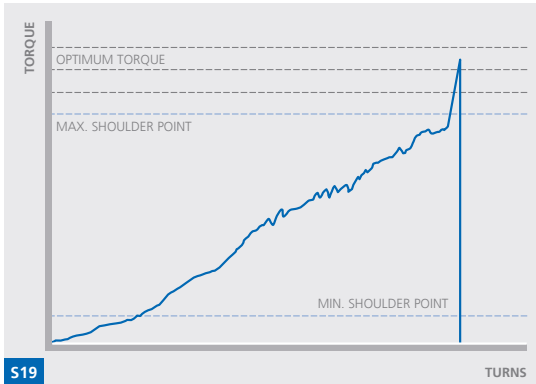
UNACCEPTABLE

High and erratic thread interference.

- Galled threads
- Contaminated thread compound
- Incorrect thread compound
- Debris on threads
- Damaged threads
- Misalignment
- Crossed threads
- High spin in speed
- Pipe movement during spin in

- Break out, clean and inspect both connections for damage.
- If no damage found re-apply thread compound then re-make up connection.

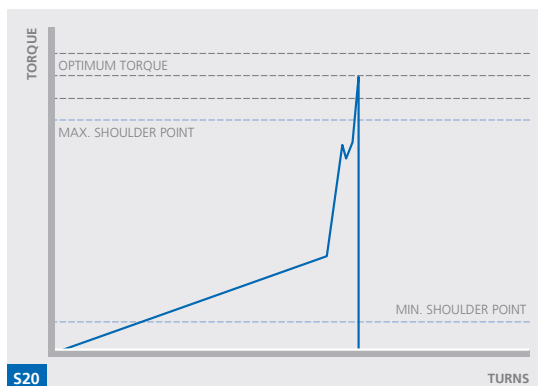
UNACCEPTABLE

Discontinuous delta torque build.

- Galled threads
- Damaged threads
- Misalignment
- Crossed threads
- Tong slip

- Break out, clean and inspect both connections for damage.
- If no damage found re-apply thread compound then re-make up connection.
- If tong slip is the cause clean or replace dies.

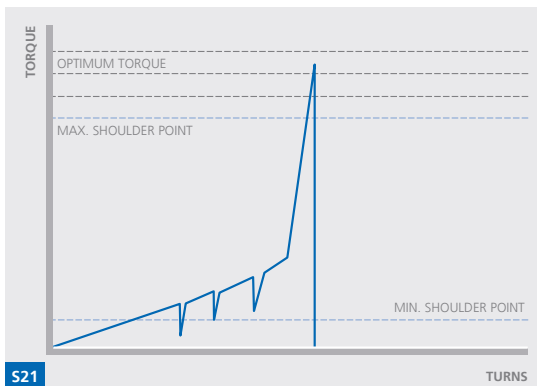
UNACCEPTABLE

Multiple tong slip.

- Clogged tong dies
- Worn tong dies
- Incorrect dies or tong jaws
- Tong not level
- Snub line movement
- Wet or oil covered pipe OD

- Break out clean and inspect both connections for damage.
- If no damage found re-apply thread compound then re-make up connection.

- Clean or replace tong dies.
- Ensure tong and back up is level and dies contact pipe OD evenly.

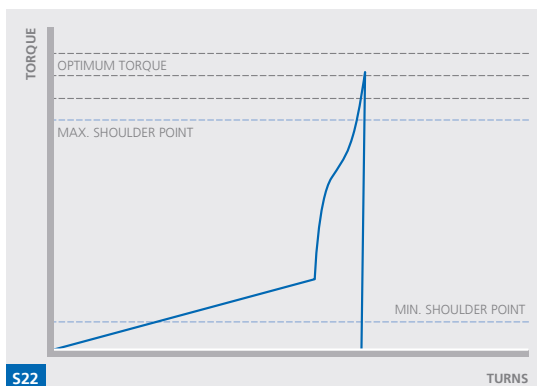
UNACCEPTABLE

Discontinuous delta torque build.

- Coupling turn
- Minor yield
- External contact on pipe from other equipment

- Break out, clean and inspect both connections for damage.
- If no damage found re-apply thread compound then re-make up connection.
- Eradicate any contact from external equipment.

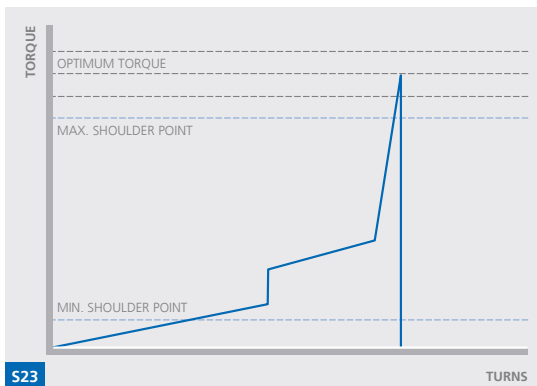
UNACCEPTABLE

Turns counter malfunction.

- Break out, clean and inspect both connections for damage.
- If no damage found re-apply thread compound then re-make up connection.
- Remedy turns counter malfunction.
