Blue[®] Series and Legacy Series Make up Acceptance

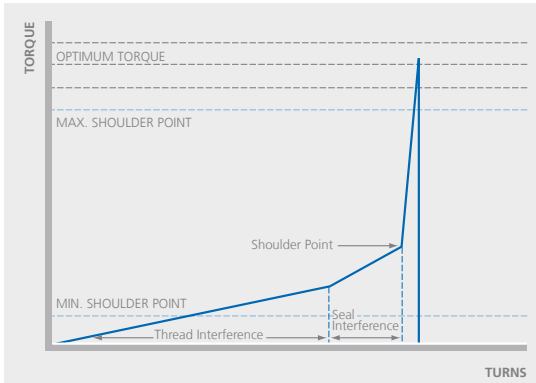
8. Occasionally some connections can exhibit a change in angle during seal engagement this is perfectly acceptable. This profile may be evident on every make up of a particular string or may occur sporadically throughout the run.

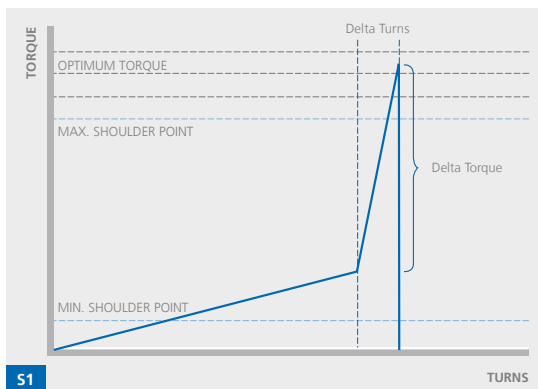
ACCEPTABLE

For Blue® Series and Legacy Series threaded and coupled connections there is a maximum allowable delta turn criteria.

The criteria for maximum allowable delta turn of Blue® Series or Legacy Series threaded and coupled connections is as follows:

- A final torque above minimum and below maximum.
- The maximum delta turn can be no more than:
 - 0.12 turns for sizes 5 1/2" and below
 - 0.10 turns for sizes above 5 1/2"
- Loss of linearity is allowed within the acceptable maximum delta turn.
- For any delta above the defined limit value reject both connections.

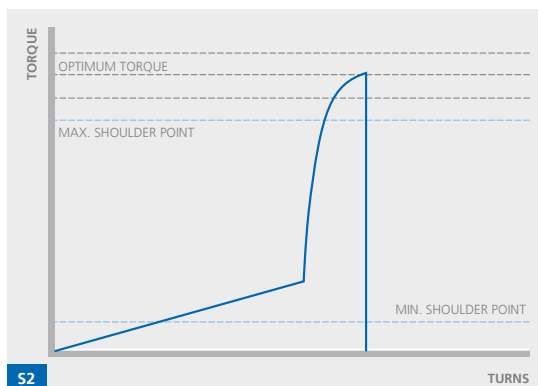
S2

ACCEPTABLE

If a graph with a larger than normal delta turn is displayed, with or without loss of linearity, the process to follow is:

- A final torque above minimum and below maximum.
- Expand the graph and ensure the shoulder point is accurately indicated, adjust if necessary.
- If the delta turn limit value is exceeded reject both connections.
- If the delta turn limit value is not exceeded accept the make up.

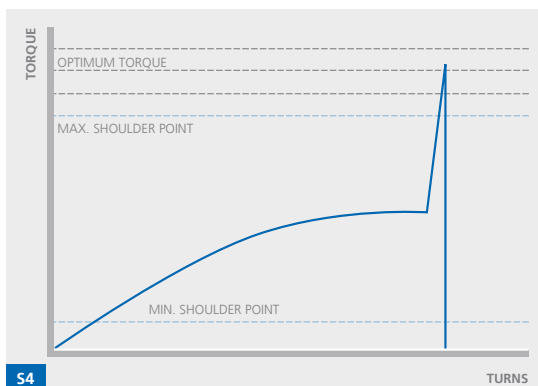
ACCEPTABLE

Curved thread and seal interference build with smooth profile.

- Excess thread compound
- High friction factor thread compound
- Low temperature thread compound
- Pipe sway
- Rig movement
- Pipe bend
- Contact on pipe by other equipment

If compound is thought to be the cause ensure it is fully stirred and warm if possible. Eradicate any contact by other equipment during make up.

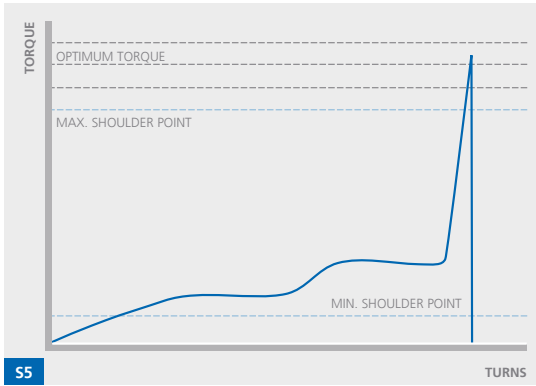
ACCEPTABLE

Minor, smooth oscillations during thread and seal interference build profile.

- Pipe sway
- Pipe bend
- Rig movement
- Contact on pipe by other equipment
- Excessive spin in speed

Reduce rotation speed if pipe sway, rig movement or pipe bend is the reason.

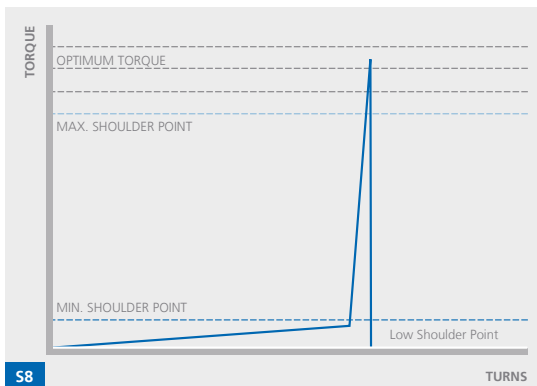
UNACCEPTABLE

Low shoulder point.

- Incorrect torque applied
- Incorrect thread compound friction factor
- Contaminated thread compound
- Substance contamination of connections
- Storage compound not cleaned off prior to application of thread compound
- Other friction reducer
- Incorrect load cell / data reading
- Low thread interference

- Break out, clean and inspect both connections for damage.
- Ensure connections are cleaned using methods recommended in cleaning section of this document.
- Ensure connections are dry if possible.
- If no damage found decrease amount of thread compound applied, respecting recommended distribution then re-make up connection.

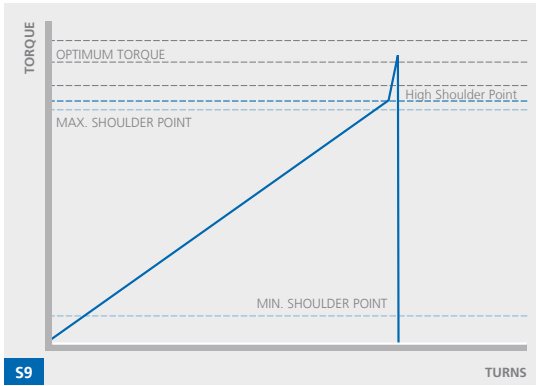
UNACCEPTABLE

High shoulder point.

- Incorrect torque
- Incorrect running compound
- Contaminated or lack of running compound
- High thread interference
- Incorrect friction factor
- Load cell problem
- Misalignment

- Break out, clean and inspect both connections for damage.
- If no damage found re-apply thread compound increasing the amount applied respecting the recommended distribution then re-make up connection.

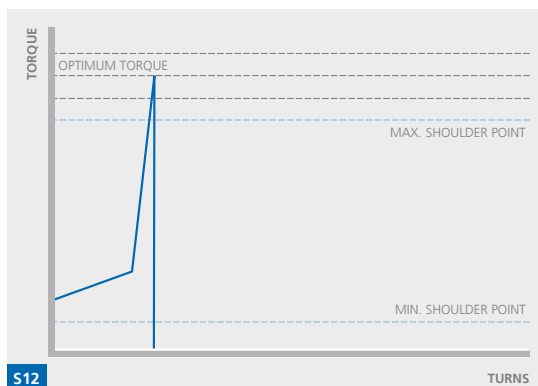
UNACCEPTABLE

Short / incomplete graph.

- Reference torque set too high
- Late gear change
- High initial interference

- Break out clean and inspect both connections for damage.
- If no damage found re-apply thread compound then re-make up connection.
- Lower reference torque.
- Stabilize pipe during stabbing and make up.

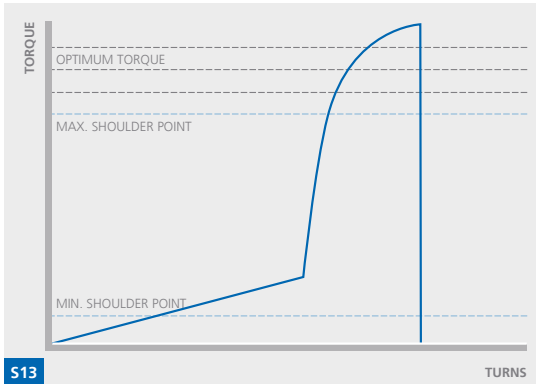
UNACCEPTABLE

Over torque with yield.

- Incorrect torque
- Incorrect thread compound
- Contaminated thread compound
- Storage compound not cleaned off correctly
- Incorrect friction factor
- Disparity of connection grade / weight
- Load cell error
- Equipment malfunction
- Incorrect tong arm length
- Operator error

Reject both pin and box connections.

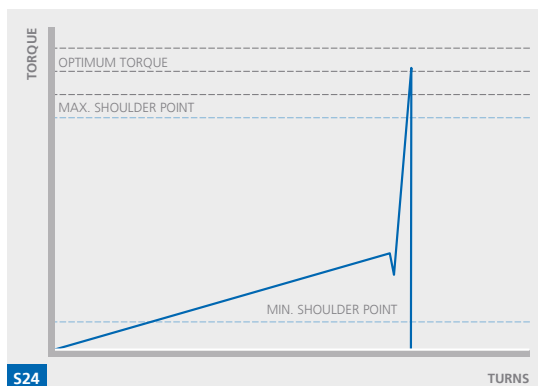
UNACCEPTABLE

Dip Prior to Shoulder

- Break out clean and inspect both connections for damage.
- If no damage found re-make connections.
- Adjust back up tong to prevent reoccurrence.
